**Docket No. 217 – Development and Management Plan Inspection**

**Date:** October 7, 2004

**Location:** Norwalk Substation Expansion

**Location:** Plumtree Substation Expansion , Bethel

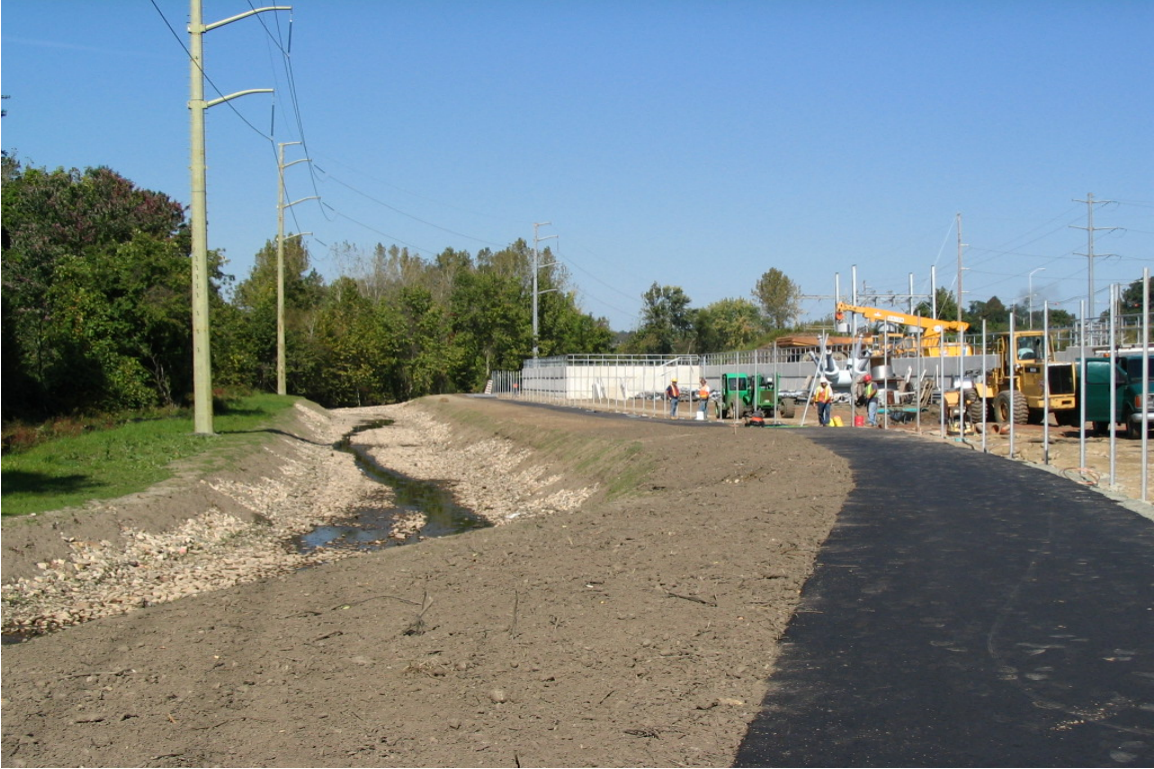
The overflow channel was repaired once again to the extent practicable following the washouts and the area was reseeded. 10/07/04

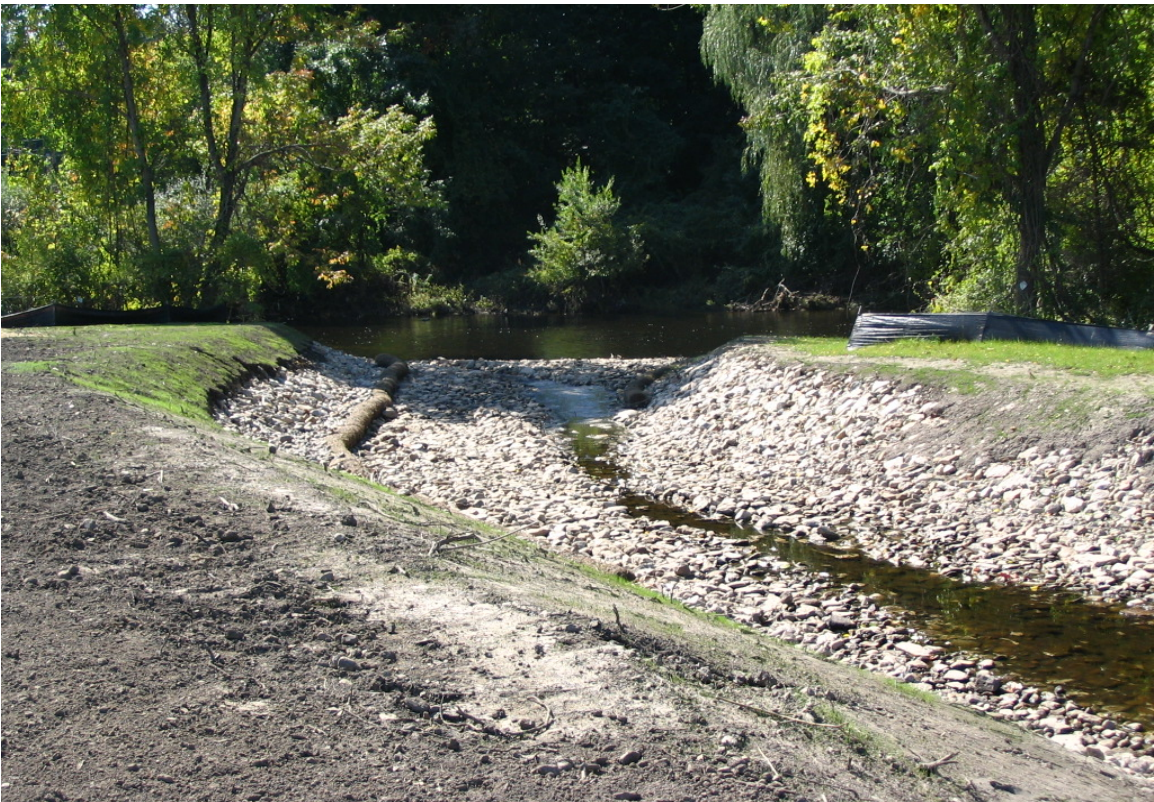
View of the southern portion of the channel where some repairs had been made following the washouts. Small amounts of revegetation are occurring. 10/07/04

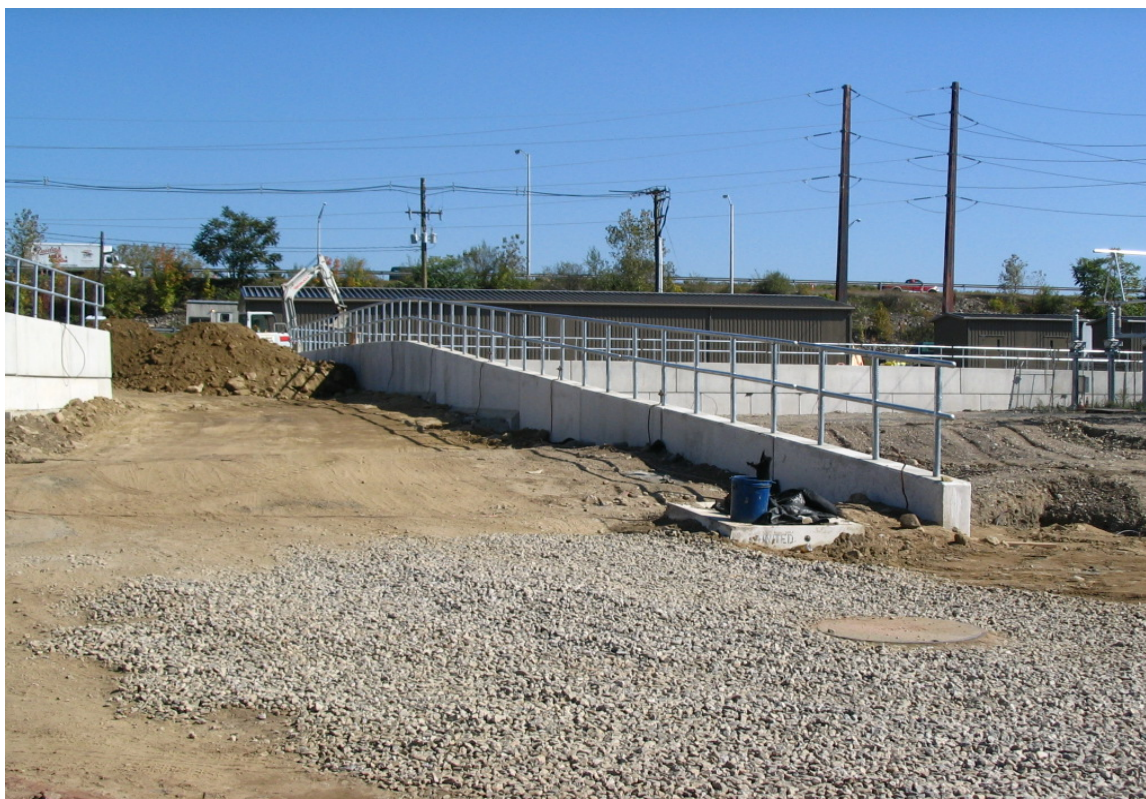
View of work to bring areas to grade at retaining wall #3. Small areas of excavations are also ongoing to install fence around perimeter portions of the yard. 10/07/04

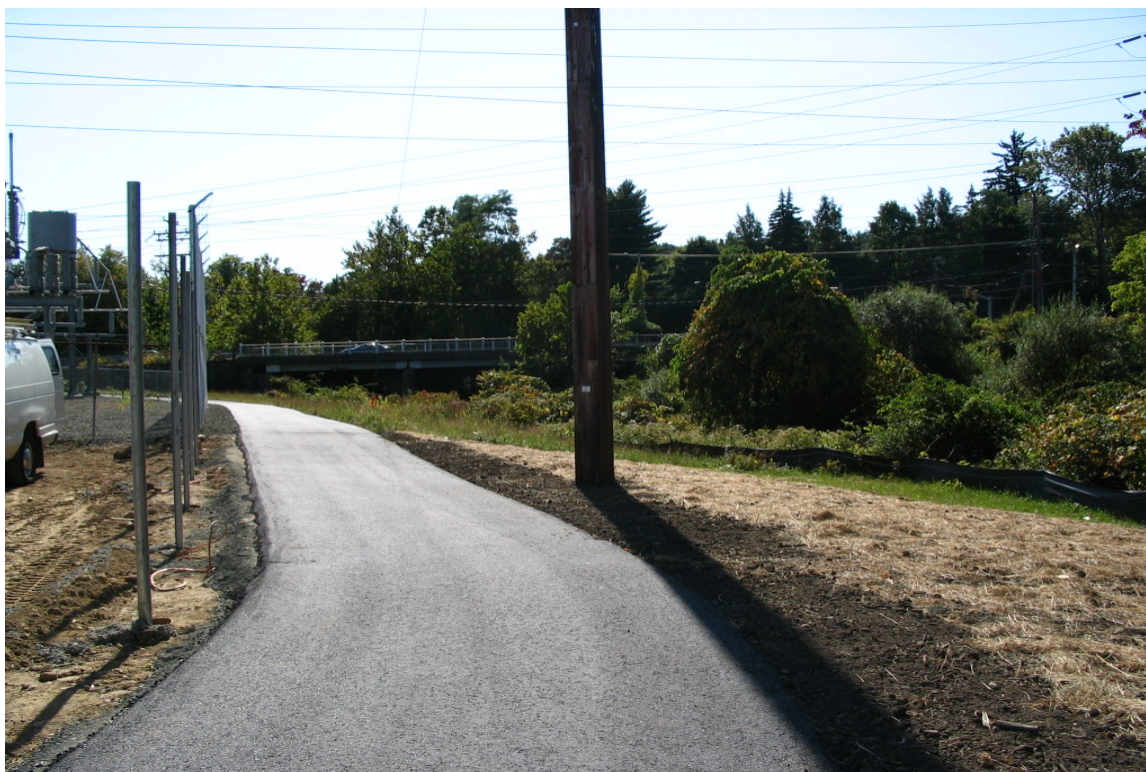
Areas of Inspection	Observation	Recommended Action
Erosion and Sediment Controls continued	- The entire length of the bike path on site was paved during the week and it is in very good shape. It stretches from New Canaan Ave to the northern end of the yard. 10/07/04	- None at this time. 10/07/04

The entire length of the bike path within the work area had been recently paved and looks very good. It stretches from New Canaan Ave to beyond the perimeter fence at the northern portion of the site 10/07/04

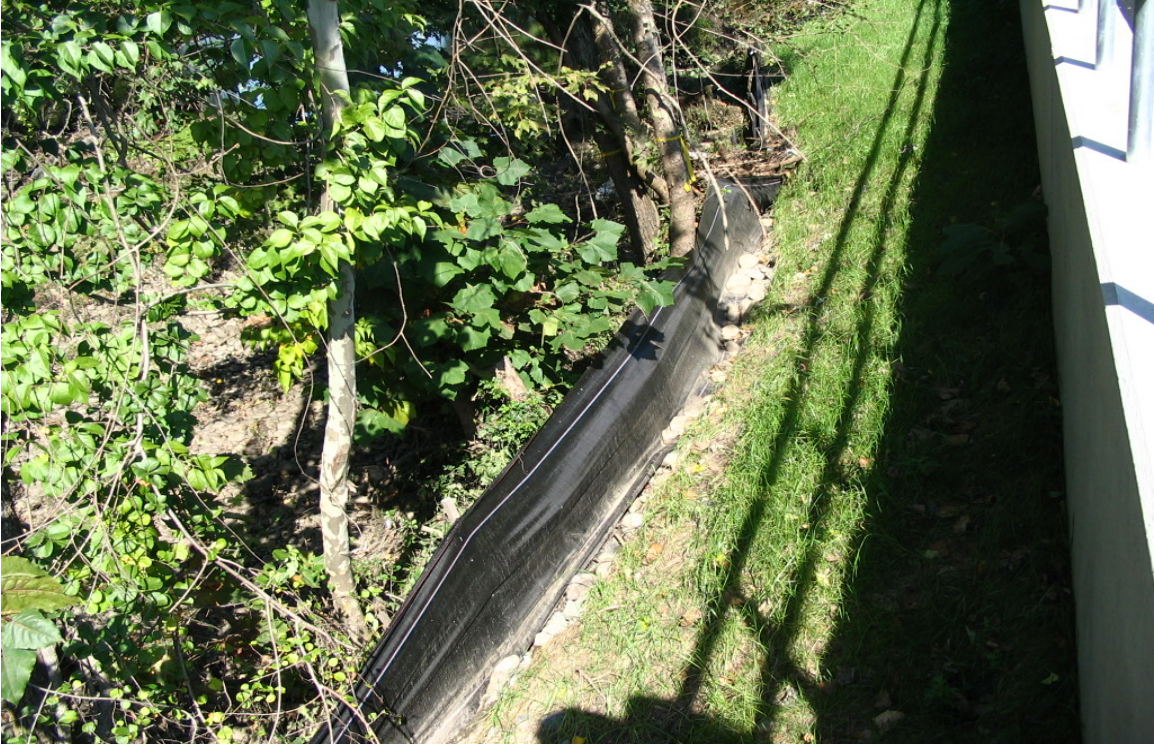
The silt fence below retaining wall #5 is showing some signs of scour at its base following the two storms. The soil is washing away slightly exposing the cobbles at the base of slope. Some additional cobbles placed here may help to prevent undercuts to the slope. 10/07/04

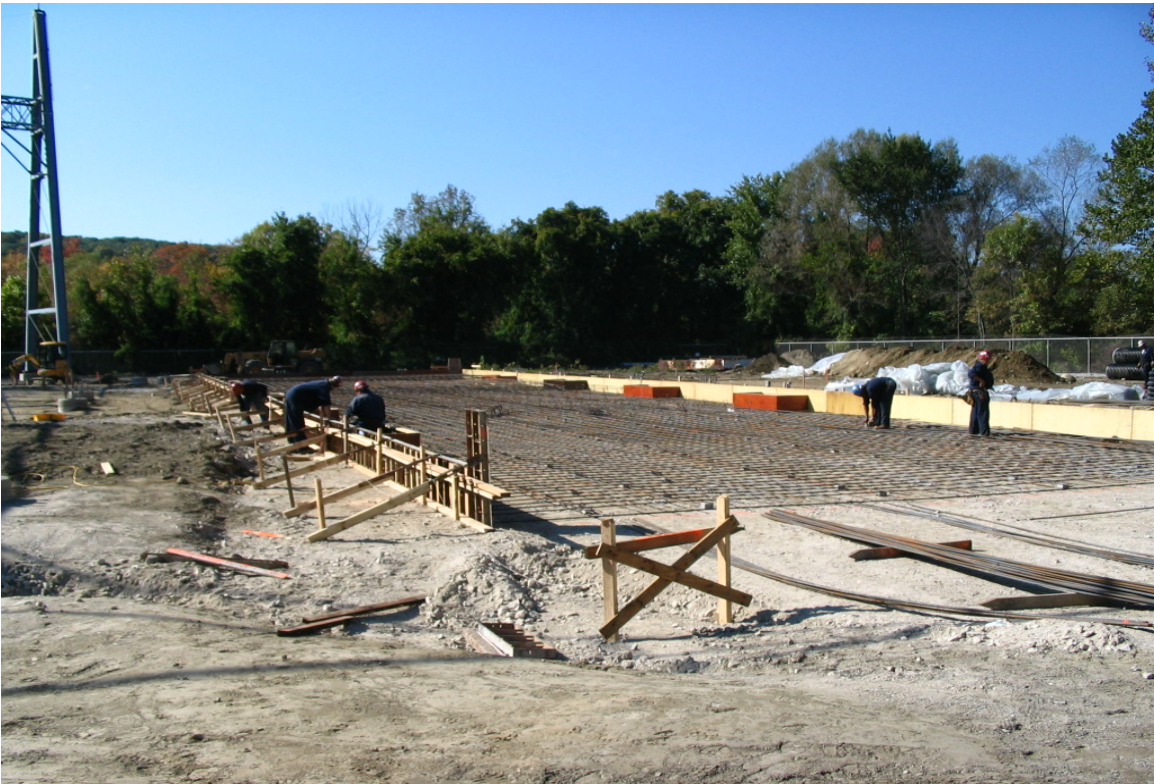
Plumtree Substation: View of the excavation for the GIS concrete pad. The area is drying out and minor amounts of dewatering are still taking place. 10/07/04
